## FACILITIES MASTER PLAN **TABLE OF CONTENTS**

## SITE MASTER PLANS OVERVIEW OF CONTENTS

## OLD RIVER ELEMENTARY SCHOOL CONDITION ASSESSMENT

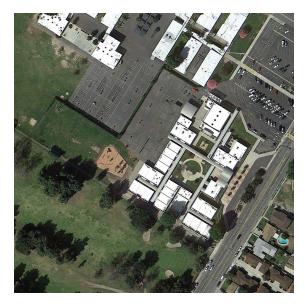
11995 Old River School Road Downey, CA 90242

- Approximately 100% of classrooms are housed in portable structures which are in fair condition.
- Permanent building (cafeteria) is generally in fair condition.
- Roofing was not included in assessment, however, condition was said to be fair and no interior water damage was evident.
- Exterior metal flashings are in fair condition.
- Exterior plaster finish is in fair condition.
- Roof overhangs/soffits and adjacent covered walkways are in fair condition.
- Exterior doors and frames are in fair condition.
- Exterior windows are in fair condition.
- Interior wall finishes are in poor/fair condition.
- Interior acoustical tile ceilings are in poor/ fair condition.
- Interior case work is generally in poor/fair

- condition.
- Tackable wall surfaces are in poor/fair condition.
- White boards are in fair condition.
- Carpet/flooring is in poor/fair condition.
- Hand-washing sinks and casework are in fair condition.
- Health care suite appears to be undersized.
- Door hardware, and thresholds are generally in fair condition and appear to be ADA compliant.
- ADA-related compliance issues are confined mostly to restrooms, however, additional barrier/clearance issues were observed.
- Accessible lift at MPR was observed.
- An assistive listening system was not observed at the MPR.
- Drinking fountain is needed in MPR.
- · Seating in MPR is not adequate.
- Flooring in MPR is in poor condition.
- Kitchen and equipment appears to be in good operating condition. Walk-in freezer is under-sized.

- Technology infrastructure needs to be updated to meet Common Core Standards.
- Most units are wall-mounted gas/electric Bard-type units which create courtyard noise issues.
- Controllability and zoning of systems is generally limited, contributing to occupant comfort issues.
- Most units are linked to an EMS.
- Administration and MPR systems generally are in need of replacement.
- Most units are served by medium pressure gas service in fair condition.

- Generally, underground piping is old resulting in low-water-pressure and is in need of replacement.
- Domestic water shut-off valves are needed for operations/maintenance.

- Kitchen piping is in fair/good condition.
- · No grease interceptors are provided.
- Irrigation systems are inadequate and in need of replacement.
- Restrooms require major upgrades and reconfiguration to meet ADA requirements.

- Service and delivery area appears to be adequately sized and located.
- Inadequate staff/parent parking, drop-off/ pick-up areas. Parking lot is shared with West MS, compounding congestion issues.

- Overall site asphalt concrete is in poor condition.
- Site concrete paving is generally in fair condition with some areas requiring repair.
- Evidence of poor drainage, puddling cracking/spalling and uneven/hazardous paving conditions observed.

- Extensive flooding occurs at outdoor amphitheater and staff patio.
- Galvanized chain mesh gates and fencing are in poor/fair condition with several ADA non-compliant conditions observed

- Play fields are grossly under-sized for population, are uneven and have drainage issues. Gophers are prevalent and create site-related hazards.
- Planting areas consist of low hedges in poor/fair condition.

- Site trees are generally in fair condition.
- School marquee sign is in fair condition.
- Lunch shelter and outdoor seating is not adequate for student population.

- Basketball goals and tether-ball poles are in fair condition.
- Ball walls are concrete block and are in need of painting.
- Bike area is in an undesirable location creating congestion at the sidewalk/ crosswalk.

- Fire access driveway and building clearances appear to be adequate.
- Inadequate vehicular and bus drop-off, congested parking circulation/exiting conditions, insufficient sidewalk area and crosswalk conditions, as well as, pedestrians crossing mid-block from residential areas present significant lifesafety hazards and require management/

- Card key access is needed at computer lab.
- Playground equipment is in fair condition, but more is needed to serve population.
   Swings are needed.
- Loose fill wood fiber is used in the elementary play areas. Play-appropriate surfacing is needed.

- Non-compliant accessible parking stall components observed.
- No passenger loading/unloading area was observed.
- Accessible warning pads (truncated domes) are not provided at curb ramps.
