FACILITIES MASTER PLAN **TABLE OF CONTENTS**

ALAMEDA ELEMENTARY SCHOOL CONDITION ASSESSMENT

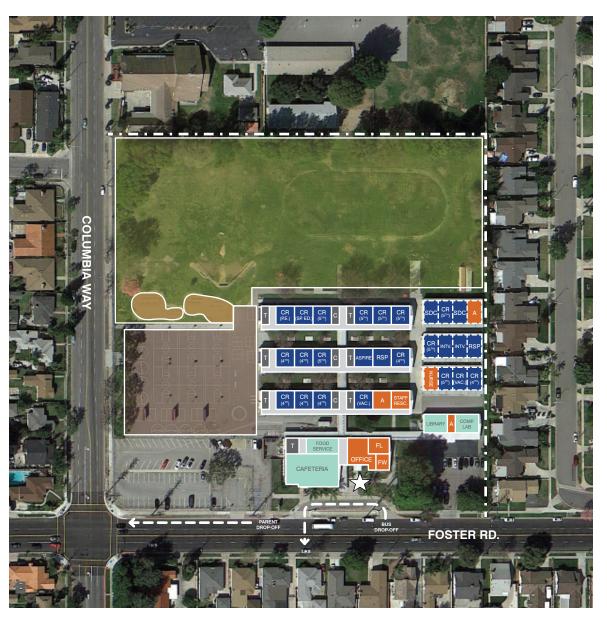
CARPENTER ELEMENTARY SCHOOL EXISTING PLAN

Classrooms, CR Science & Art Lab Shared Spaces Admin / Faculty FW - Faculty Work, FL - Faculty Lounge Support Spaces X - Storage, T - Toilets, U - Utility, E - Electrical, D - Data, C - Custodial Play Fields Learning Courts Play Equipment Hardcourts

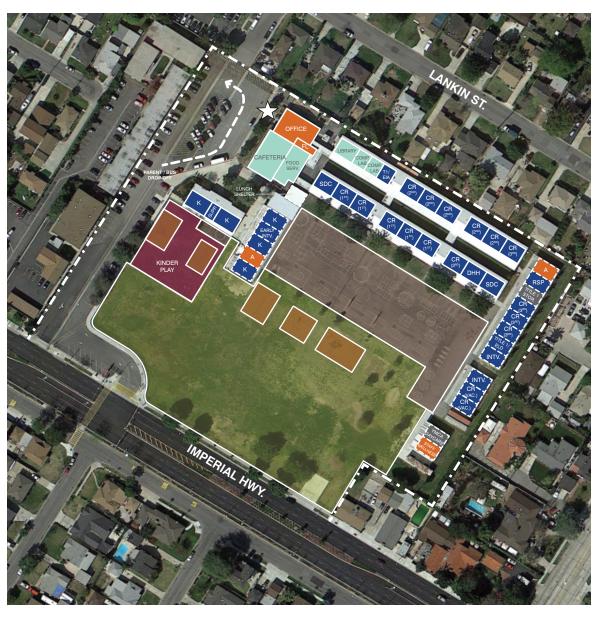
IMPERIAL ELEMENTARY SCHOOL EXISTING PLAN

Classrooms, CR Science & Art Lab **Shared Spaces** Admin / Faculty FW - Faculty Work, FL - Faculty Lounge Support Spaces X - Storage, T - Toilets, U - Utility, E - Electrical, D - Data, C - Custodial

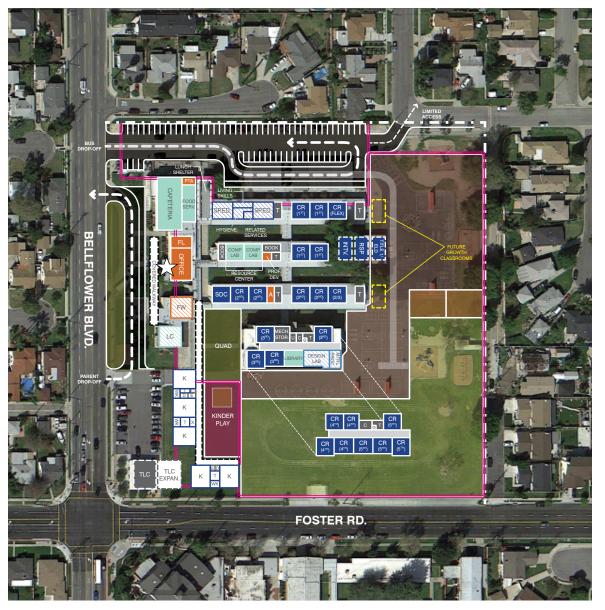
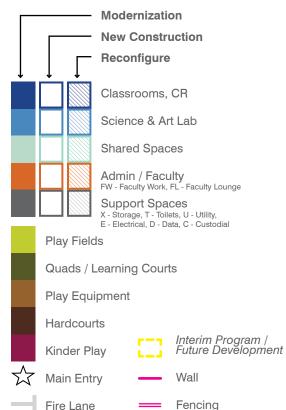
LEWIS ELEMENTARY SCHOOL **PROPOSED MASTER PLAN**

Teaching Stations:			
Kindergarten, K	5	Resource Specialist, RSP	1
Transitional Kinder, TK	0	Special Day Class, SDC	1
1st - 5th Grade	22	Learning Center, LC	1
		Special Education, SP.ED	2
Science & Art Lab	1	Intervention, INTV.	1
Computer Lab	2	Early Intervention, Early INTV.	0
		Occupational Therapy, OT	0
		Deaf/Hard of Hearing, DHH	0
		Title 1 / ELD	1
		Other	0
		Open / Vacant	0
